On March 23rd 2005, the BP petroleum refinery in Texas City, TX experienced a major explosion and fire that resulted in the death of 15 workers, the injury of over 100 people, and massive damages that resulted in a two-year shutdown for a major unit in the refinery.

Workshop on BP Texas City Accident

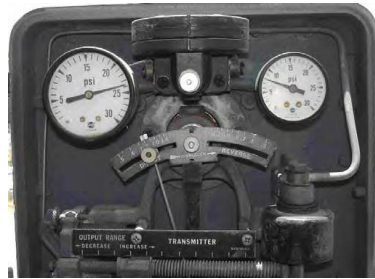
6

Tower bottoms level sensor used out-of-date density for liquid. Also, the actual density changed as the temperature changed.

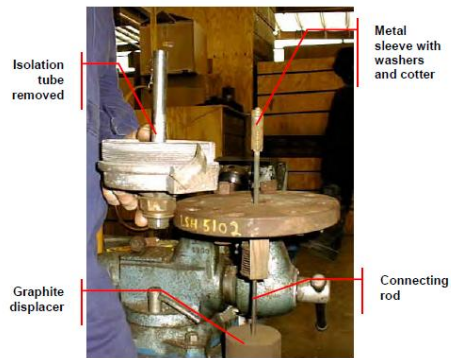
7

Tower bottoms level float and alarm switch. Study indicates that the cause of the failure was likely the switch, not the displacer.

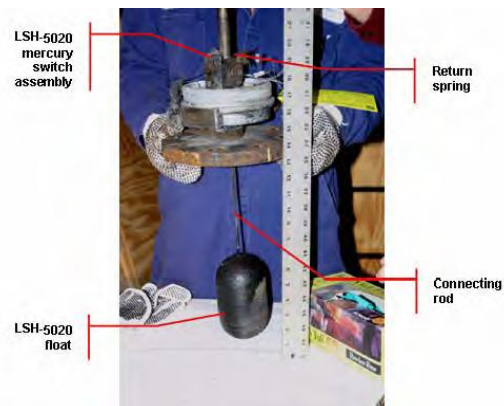
8

The blowdown drum level alarm. Investigation showed that the (hollow) float had a hole due to corrosion. It was filled with liquid, and naturally, did not float.
